REPORT NUMBER: 100604363TOR-005a ISSUE DATE: March 30, 2012

Primus 4x4 post anchors

Load Tests on Guards

Report of load testing for Titan Building Products of the 4×4 Primus post anchors to be used with guard rail systems for compliance with the applicable requirements of AC273 "Acceptance Criteria For Handrails And Guards", Approved February 2008."

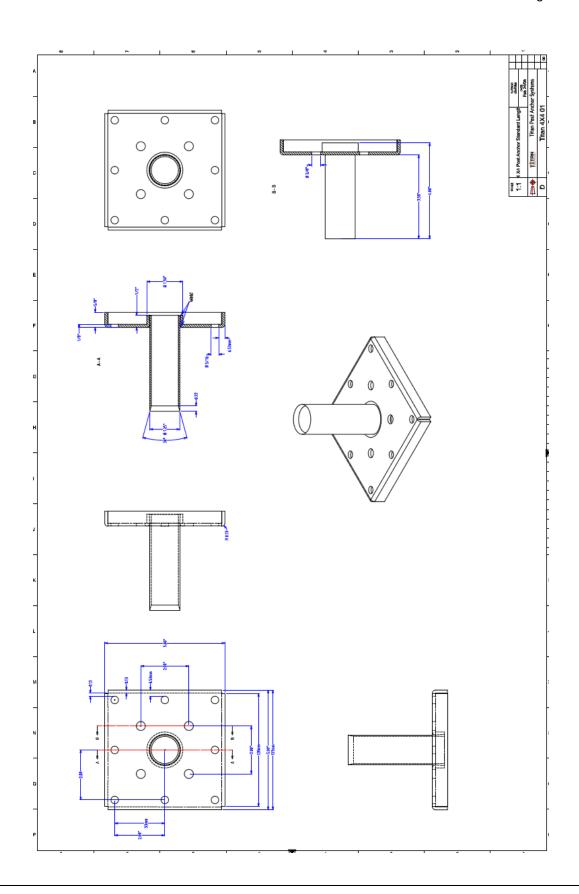
<u>Post Anchor Drawing:</u> Titan Post Anchor System – Titan 4X4 01, dated Feb 24, 08. (3 pages)

The description below outlines the components and construction of the post anchor system assembled with 4x4 Primus post anchors and 4x4 SPF wood posts.

A steel top and bottom rail was affixed to the posts. The top side of the top rail measured 42" (1067 mm) from the deck floor. The bottom side of the bottom rail measured 4" (102 mm) from the deck floor. A vertical steel member spanning the top and bottom rail was also fastened at the centre of the guard rail. This represented the baluster of a guard rail system.

Each post was assembled with a  $4\times4$  Primus post anchor. Each post anchor was assembled to the post as per the packaging instructions. Each pressure-treated SPF post measured 89 mm by 89 mm by 1118 mm (3.5"  $\times$  3.5" by 44") long.

A 1-1/4" diameter hole saw was used to cut a circular pilot cut identical to the diameter of the tube in the centre of the  $4\times4$  post about 42-48 mm (1-5/8" to 1-7/8") deep. The inner wood core of the cut remained and the sharp edge of the tube was aligned and set into the pilot cut at a vertical attitude and driven with force into the solid core of the post until the base of the anchor was flush against the post bottom. Four pilot holes measuring 1/4" diameter were drilled a minimum of 50mm (2") deep into the post. Then, four  $3/8"\times5"$  lags screws fastened the anchor to the post.

Each post was fastened into an SPF base that measured 76 mm (3") thick (fastened perpendicular to the wood grain) with eight #14x3" screws.

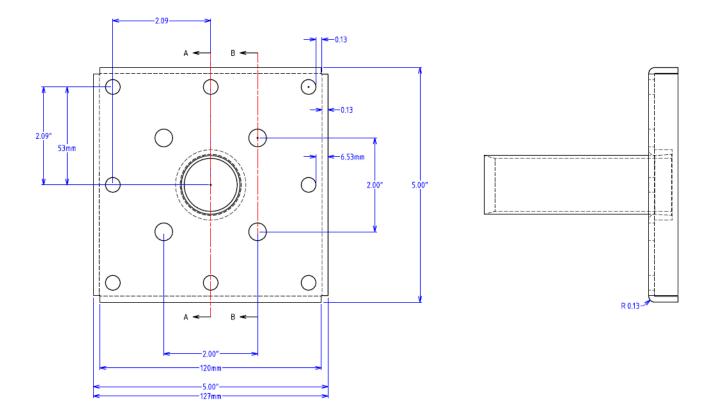
Drawing 2. – Zoomed in drawing of 4x4 Primus post anchor (top-view)

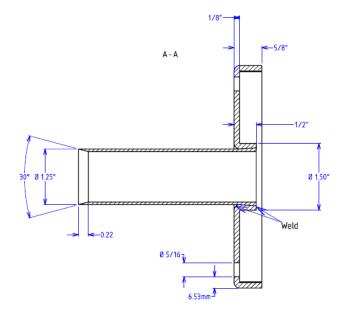
Drawing 3. – Zoomed in drawing of 4x4 Primus post anchor (side-view)
